LIONSHEAD LAKE DAM

PHASE I INSPECTION REPORT

NATIONAL DAM SAFETY PROGRAM

NJ 00254

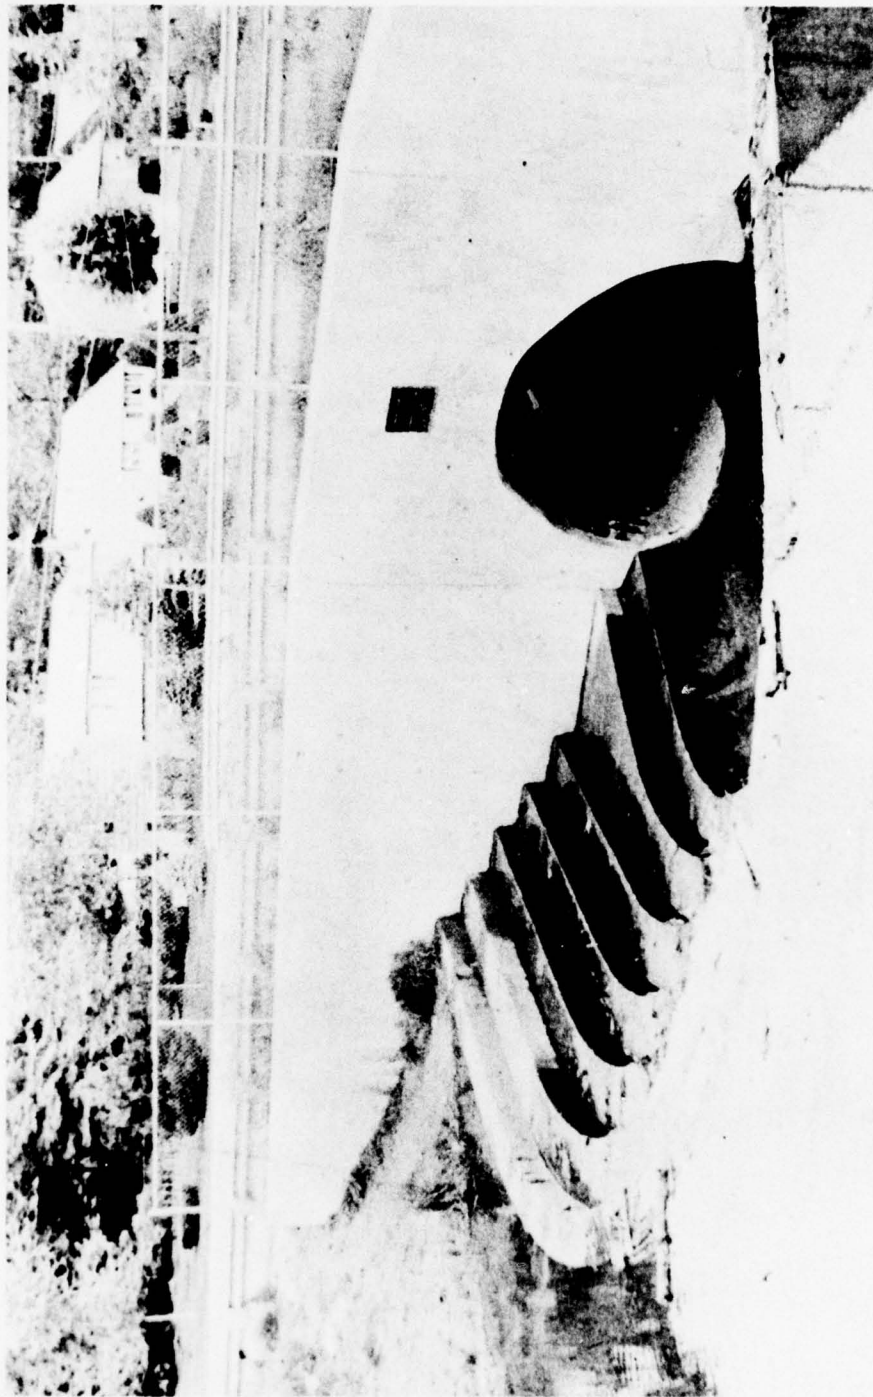
OVERALL VIEW OF DAM

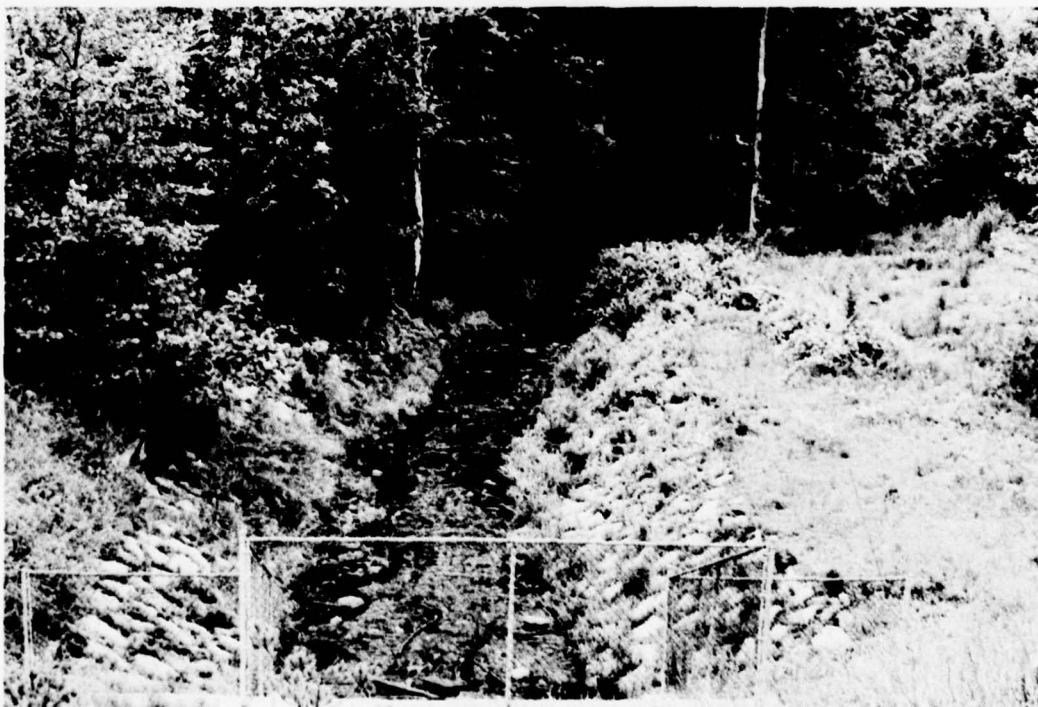
PHOTO 6

Photo 6 - View Downstream (North) Along Outlet Channel From Crest of Downstream Slope of Dam (Culvert Outlet Headwall at Bottom Center of Photo. Riprap on Stream Banks Extends 85 Feet Downstream From Culvert Outlet. The Riprap Lines the Slopes to a Height of Five Feet Above the Streambed Level.) - 13 June 1978
